Dealing with legacy pin 1 problems

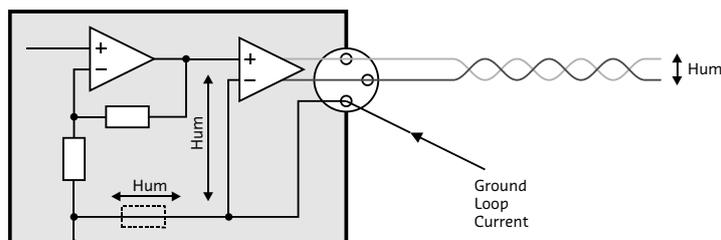
Hum is often presented as something that only affects inputs. That’s a flawed assumption. Here’s a drawing showing an *output* which picks up hum injected through pin 1.

The loop current flows through the internal reference node (“audio ground”) and causes a voltage to develop in the wiring resistance of this node. Hum is introduced everywhere in the circuit.

The root cause is the fact that an unthinkingly connected pin 1 functions as an unplanned input that gives direct access to an internal wire that nobody has any business with. This is completely unnecessary and counterproductive.

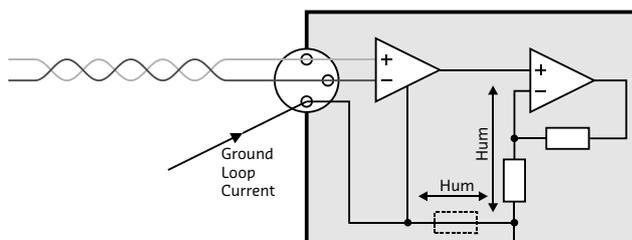
For completeness, here’s the same drawing for an input.

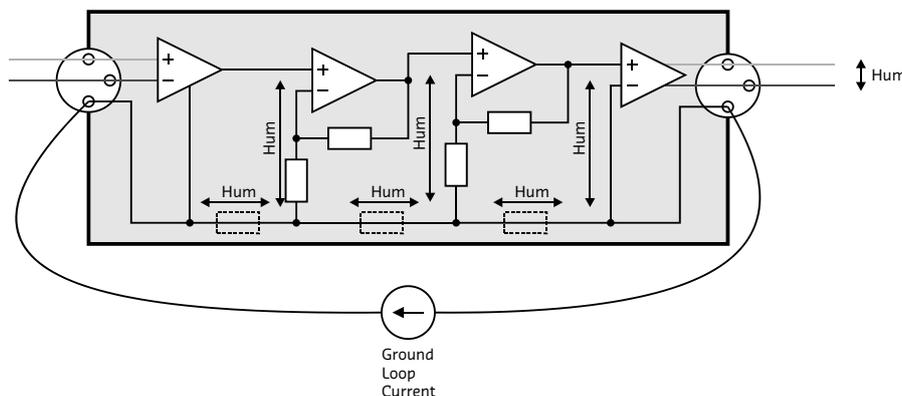
There are several reasons why this is flawed. First the *glaringly* obvious one: the chassis isn't always part of the loop, and disconnecting it will have no effect. As soon as you connect a second XLR, you're once again running your ground loop current all the way through your audio circuit.

Didn't help, did it? All that time invested trying to convince suppliers to make special parts with insulated screw holes and it just doesn't bloody work. **Lifting the ground is no solution.** It only helps to some degree when you have *exactly* one audio connector (an input or an output). But how many products can we think of with only one output and no input or vice versa? As soon as a second XLR turns up, that's the end of it. There is not a single documented case of an EQ or a compressor in which a ground lift switch has ever solved a hum problem. Didn't stop anyone from adding ground lift switches though and feeling smug about it.

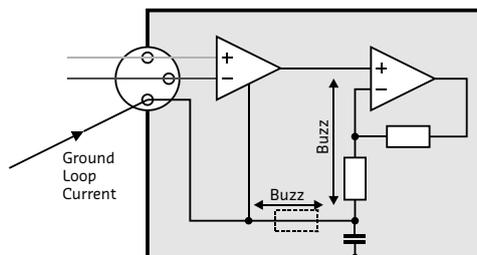
The second reason is that for various EMC related reasons the circuit still ends up capacitively coupled with the chassis. Depending on the case, the capacitances range from nanofarads to microfarads.

Now, a 500nF capacitor may be a high impedance at 50Hz, at 4kHz it's not. Hum with the fundamental and lower harmonics removed is called "buzz". It's hardly an improvement.
